Water Quality in the Beaver Creek Watershed

2006

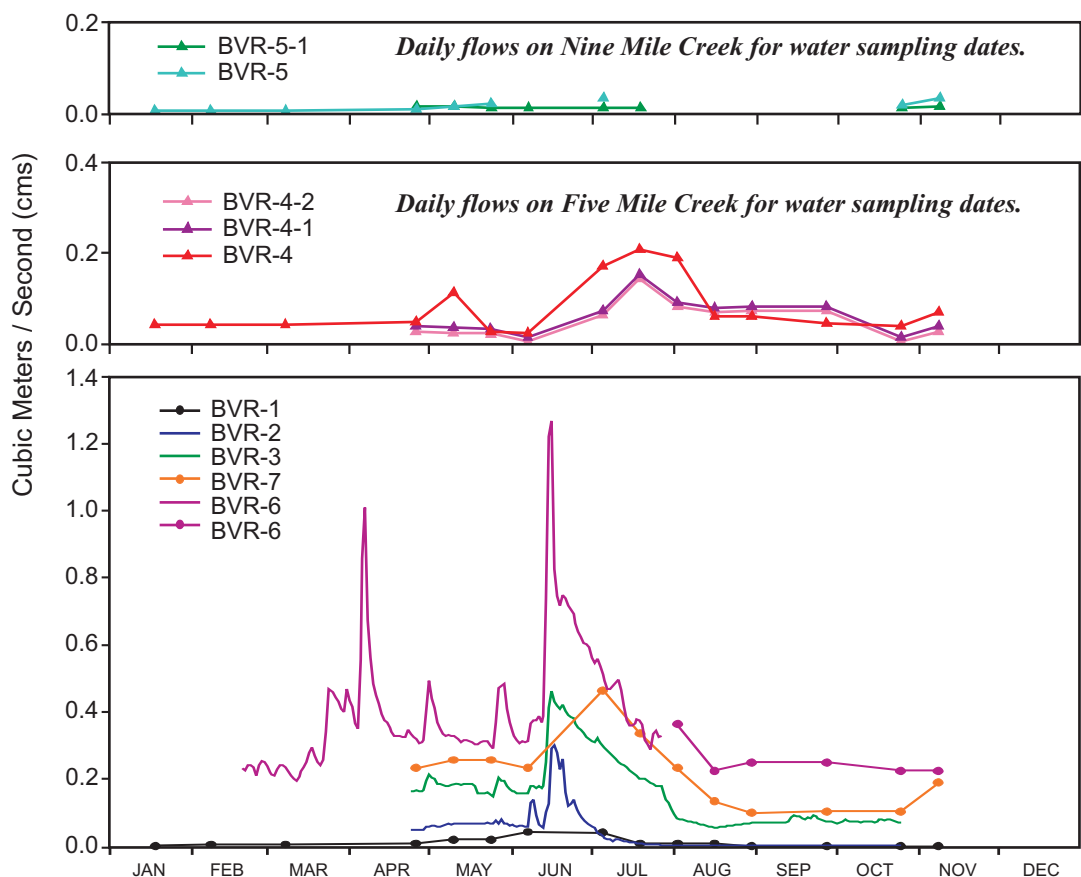
Figure 3. Mean daily flows from main stem water quality monitoring sites in 2006. (Solid lines represent continuous flow data, dotted lines represent flows calculated from staff gauge readings.)

The mean daily flow in Beaver Creek for 2006 ranged from 0.2 to 1.27 cubic metres/second (cms), as recorded at BVR-6 (Figure 3). Peak flows occurred in April and June, following rainfall events. Throughout the year, any significant rainfall usually resulted in an increase in flow in the creek. Underground springs discharging to the surface feed Beaver Creek throughout its reach, resulting in increased flows as water moves down through the basin. Five Mile Creek (BVR-4) is a major tributary to Beaver Creek that flowed all year long. The tributary Nine Mile Creek (BVR-5) flowed through the winter, spring and early summer but then went dry for a period of time before it started flowing again in late October.
