Beneficial Management Practice Evaluation in the Battersea Drain and Lower Little Bow River Watersheds

This 2007 fact sheet on Beneficial Management Practice Evaluation in the Battersea Drain and Lower Little Bow River Watersheds is one of a series of information bulletins on agriculture and resource management produced by the Irrigation Branch, Alberta Agriculture and Food.

IB001-2007

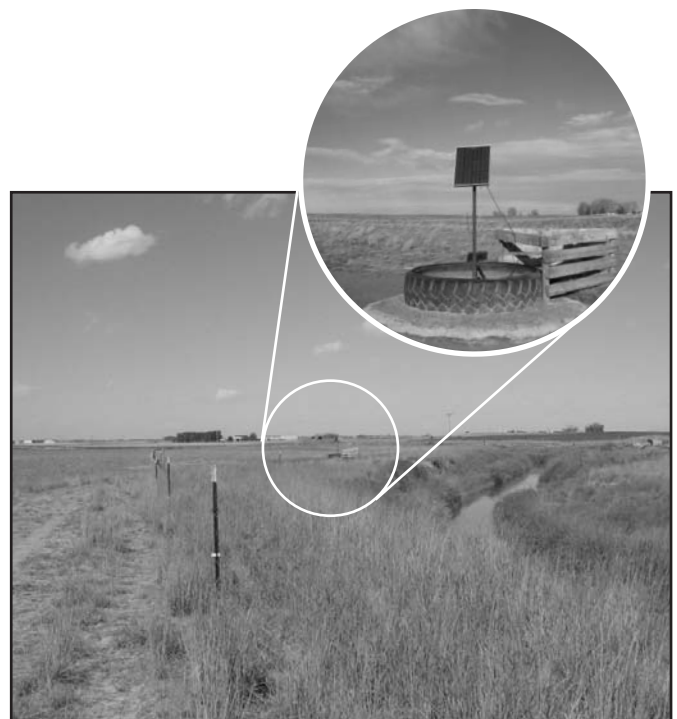
Figure 3. Livestock exclusion BMP along the Battersea Drain with electric fencing protecting the riparian zone as well as a solar pump and trough providing water.

Livestock with unrestricted access to waterways can contaminate water with manure and erode banks. Restricting livestock access eliminates the deposition of animal wastes in the water, minimizes shoreline and bottom disturbance, and protects vegetation along waterways. Approximately 20 cow/calf pairs were excluded from 800 metres of the Battersea Drain with an electric fence. A solar pump and trough provided off-stream water for the cattle (Figure 3).

Analyses comparing TN and TP **before** and **after** BMP establishment indicated no reduction in concentrations or loads. The FC data were not available for the pre-BMP period. Statistical analyses of paired water quality data **upstream** and **downstream** of the BMP did not indicate any differences in TN, TP, and FC concentrations or loads. Livestock exclusion BMPs may be considered effective if water quality is improved or maintained within the waterway corridor where the livestock are present; however, it is not possible to conclusively attribute the observed uniform water quality to this livestock exclusion BMP because paired upstream and downstream data were not available to confirm the initial impact of the cattle on water quality before they were excluded from this section of the drain.

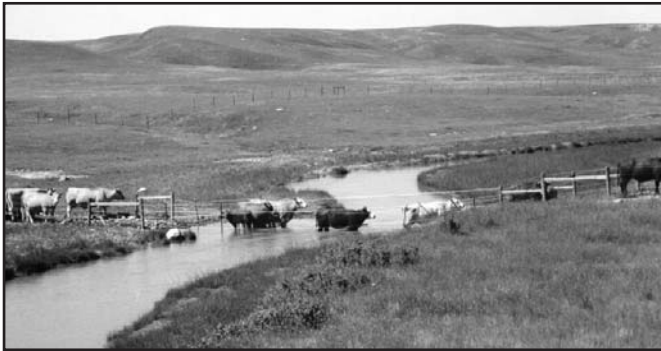
Figure 4. Rotational pasture BMP limiting livestock access along the Lower Little Bow River.

Pasture management practices that include the use of rotational grazing systems are beneficial for water and soil quality. Systems that include the riparian area as a separate pasture are beneficial because livestock access to these areas is controlled to limit the impact on the riparian plant communities. Approximately 800 metres of riparian area along of the Lower Little Bow River was fenced on both sides and a river crossing was constructed to limit cattle access to the river but still permit cattle access to the pasture on the other side. A solar pump and trough provided off-stream water for about 100 cow/calf pairs and gates provided an opportunity to use the three pastures (north side, south side, and riparian area) in a rotational grazing system (Figure 4).

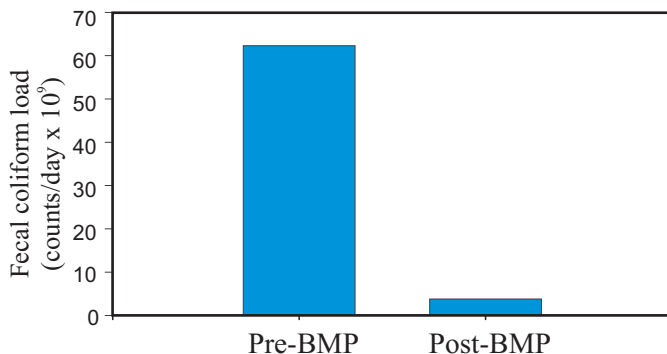
Figure 5. Median fecal coliform load in the spring before (1999-2001) and after (2002-2006) rotational pasture BMP implementation.

Data analysis **before** and **after** BMP establishment indicated a highly significant reduction in the FC load in the spring (Figure 5). Overall, TN and TP concentrations and loads increased after BMP establishment, which can be attributed to higher run-off and flow during the very wet summers of 2002 and 2005. No upstream and downstream analyses were conducted for this BMP, as there was no suitable upstream site.

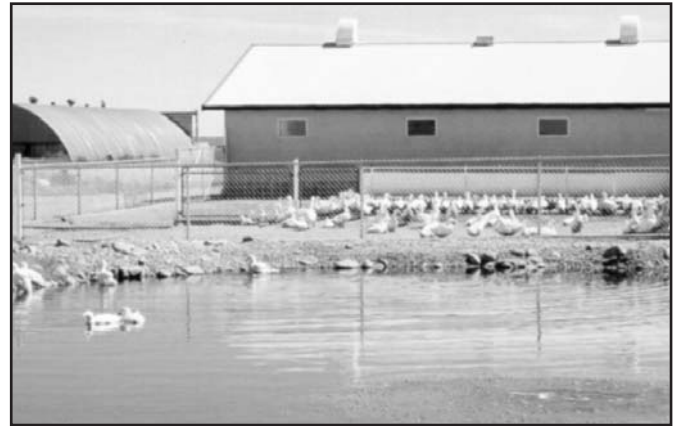
Figure 6. Goose pond relocation BMP located away from the irrigation return flow drain.

Livestock access to waterways may have a negative impact on water quality as deposition of animal wastes increases nutrients and bacteria in the water. A pond used in a goose production operation was relocated from its original location on an irrigation return flow drain which discharge into the Lower Little Bow River. A new pond was located away from all watercourses and lined to prevent seepage (Figure 6).

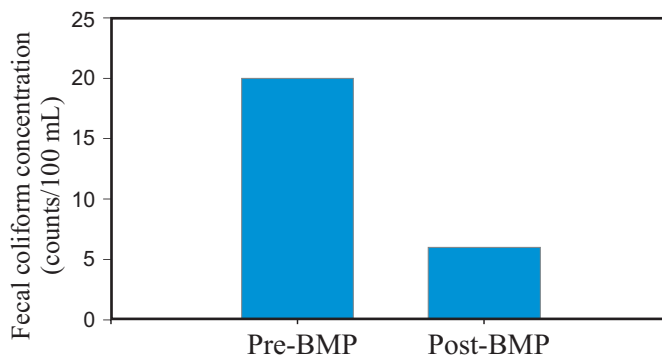
Figure 9. Median fecal coliform concentration in spring before (1999-2002) and after (2003-2006) diversion berm BMP implementation.

Data analyses **before** and **after** BMP establishment indicated a reduction in FC concentrations after

construction of the berm (Figure 9). This trend was most noticeable in the spring when snowmelt occurred. The FC loads pre- and post-BMP remained constant, in spite of the high flows in 2005 post-BMP, indicating a positive effect of the BMP. Concentrations and loads of TN and TP increased post-BMP. These increases were the strongest in the irrigation season (May-Oct.) and can be explained by major precipitation and runoff events for this time period in the post-BMP years. Analyses of data **upstream** and **downstream** of the BMP indicated no changes in TN, TP, or FC concentrations.
